Special Report 78-17

September 1978

EFFECTS OF WINTER MILITARY OPERATIONS ON COLD REGIONS TERRAINS

Prepared for
DIRECTORATE OF FACILITIES ENGINEERING
OFFICE, CHIEF OF ENGINEERS

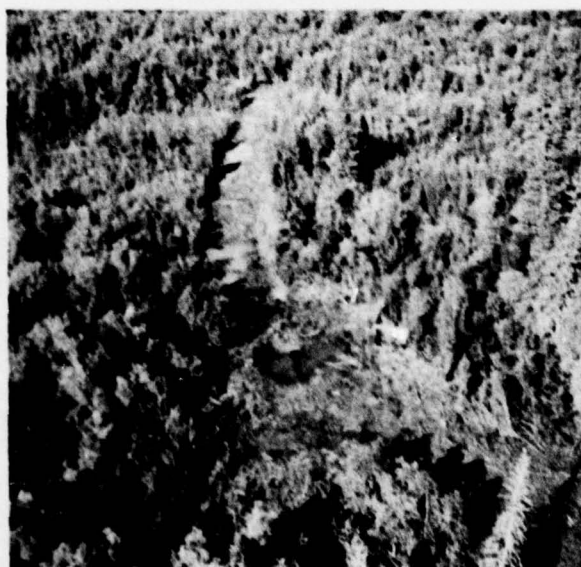
An aerial view of site 16 is shown in Figure 18, and of site 17 in Figure 19.

Figure 19. Aerial view of site 17.

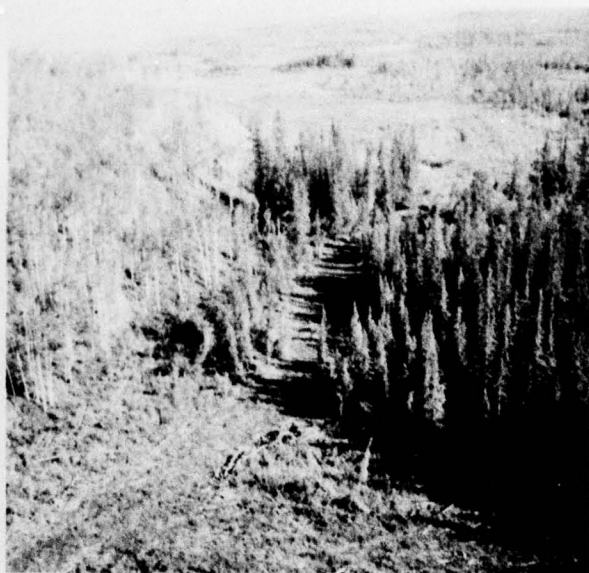
An aerial view of site 18 is shown in Figure 24, and of site 19 in Figure 25.

Figure 24. Aerial view of site 18.

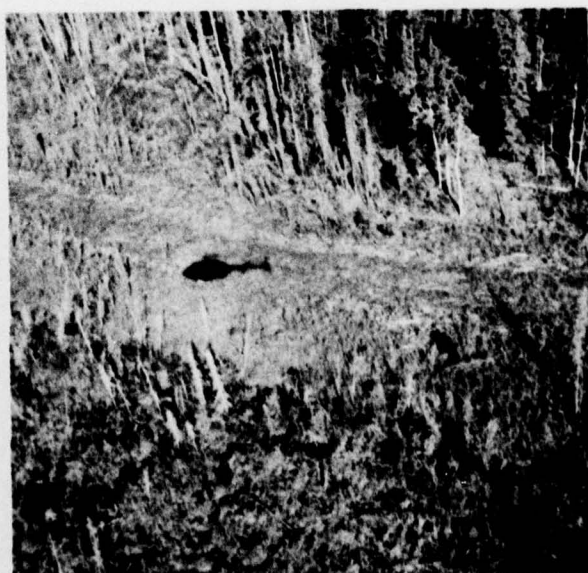
19

Figure 25. Aerial view of site 19.

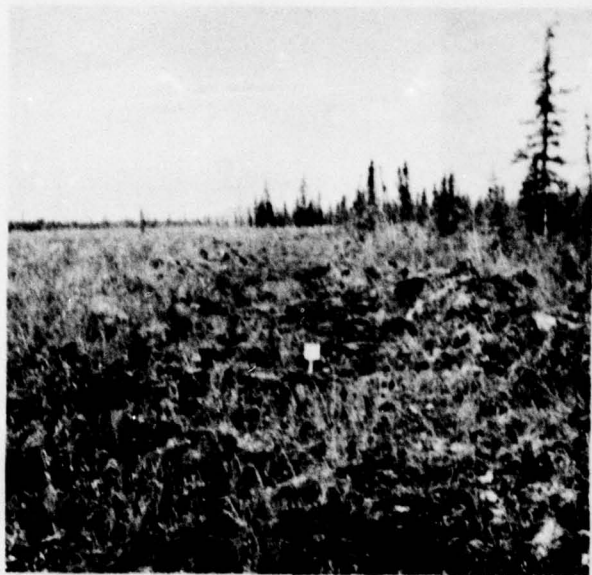
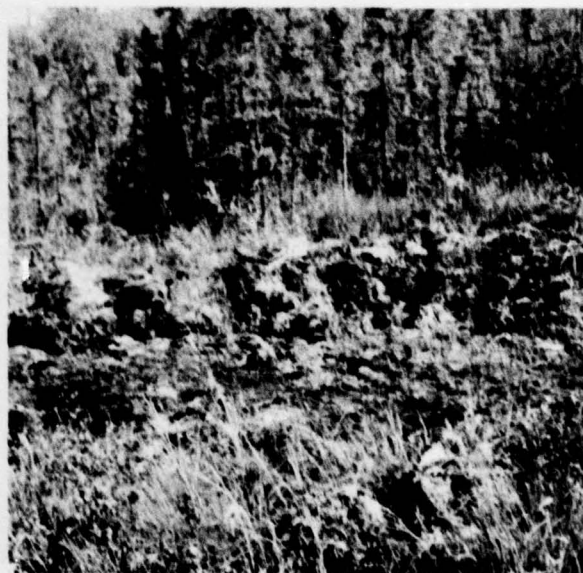
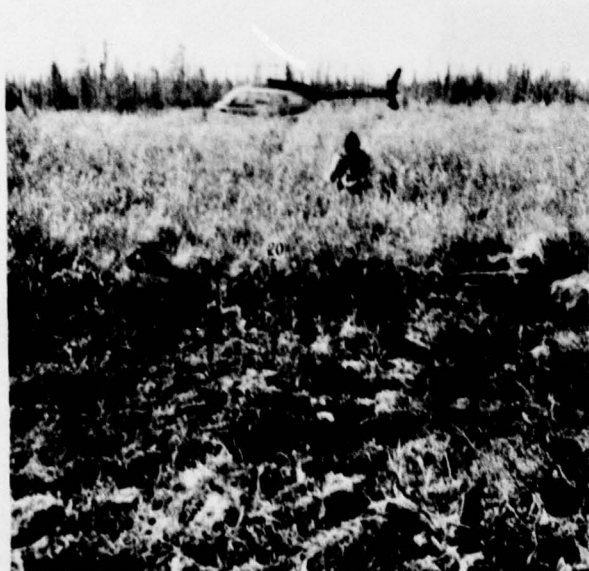
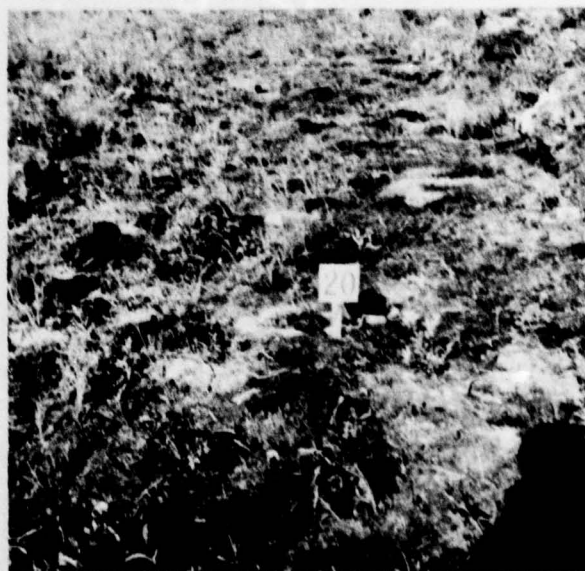
Site 20 (Figs. 32 through 35). A shrub-tussock community, adjacent to a spruce stand, similar to sites 14 and 15, but better drained, the dominant species being willows, resin birch, various berry bushes, grasses and mosses.

Figure 32. Site 20
(looking N).

Figure 33. Area adjacent to site 20
(looking E).

Figure 34. Area adjacent to site 20
(looking W).

Figure 35. Site 20, closeup
(looking N).

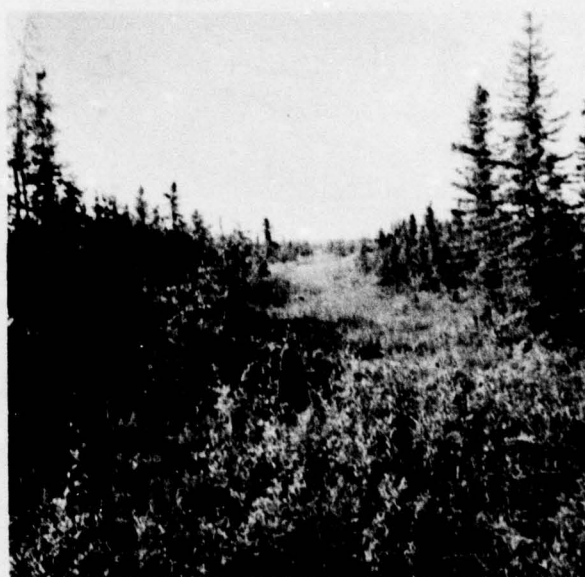
Troop concentration (artillery) (Figs. 36-39). This area has been used during previous maneuvers (for location refer to Fig. 3). The three old trails that converge toward the observation tower appear to have been cut a number of years ago. The lack of any significant berms along the trail edges implies little or no blade penetration below the terrain surface. While there is a healthy regrowth of grasses, very little regrowth of shrubs could be observed (Figure 38). For comparison, the new trail, on which Site 20 is located, is shown in Figure 39.

Figure 37. Trail at troop
concentration (artillery)
area (looking W).

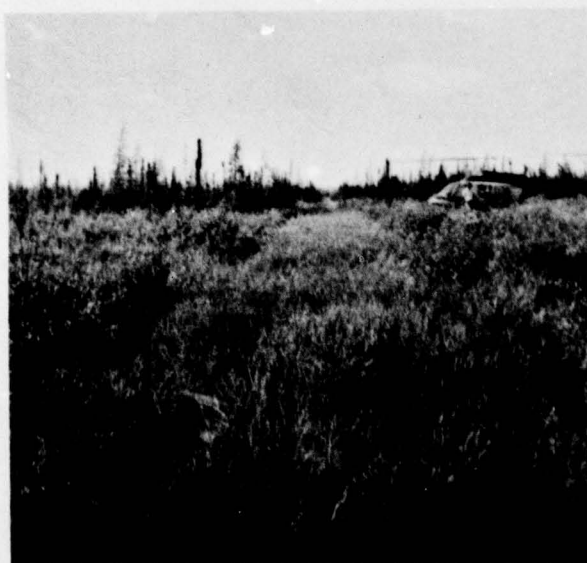
Figure 38. Old trail
(looking W).

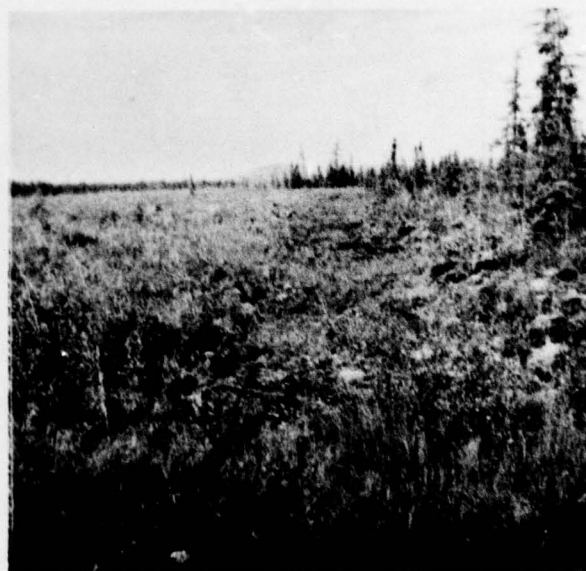
Figure 39. New trail
(looking N).

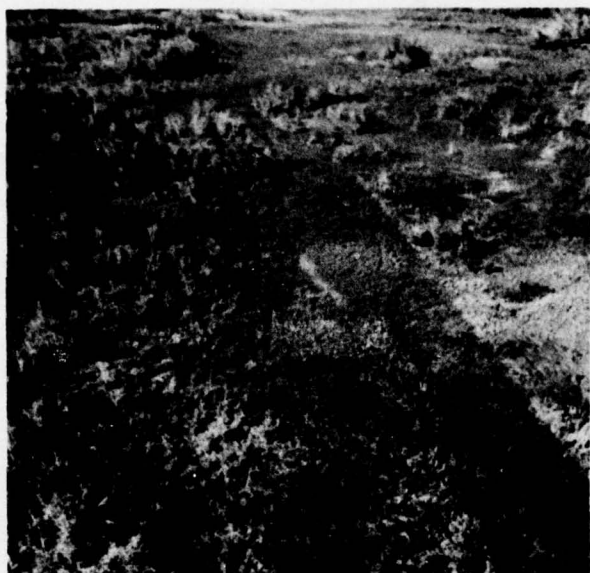
Trail over bog (Figs. 40 and 41; refer also to Fig. 70a). An open bog, with sedge and horsetail as dominant species and willows on moss covered high points, the vegetation mat floating on standing water 0.6 to 1 m deep.

Figure 40. Trail with minor disturbance south of Clear Creek Butte (looking N).

Figure 41. Same trail (looking E).

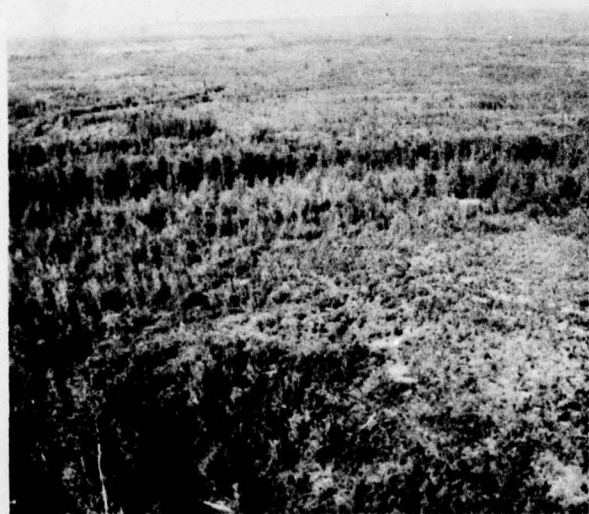
Command post (Fig. 42) and Landing area (Fig. 43) are shown for record purposes only.

Figure 42. Command post location north of Clear Creek Butte (looking N).

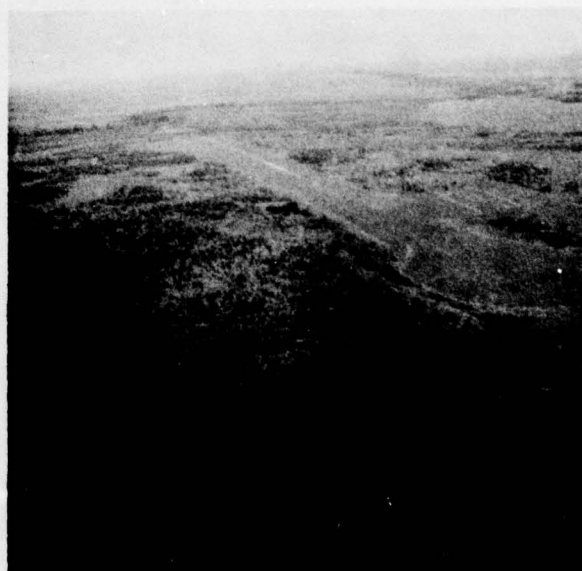
Figure 43. Clear Creek landing area (looking S).

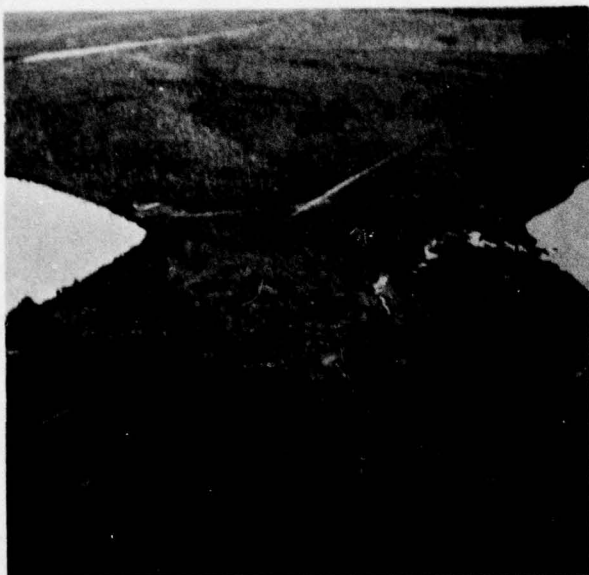
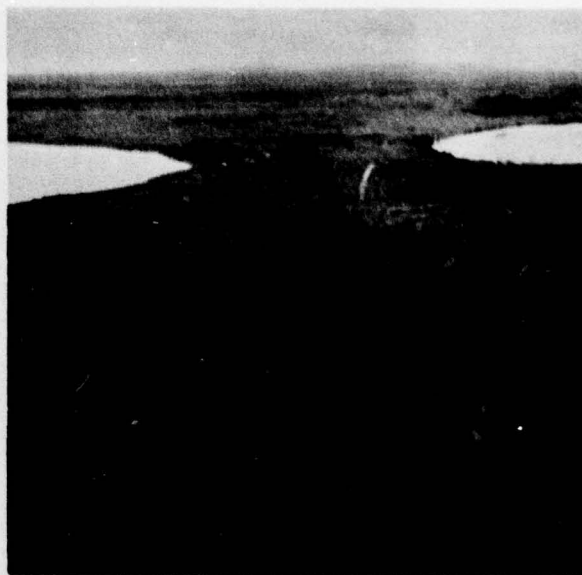
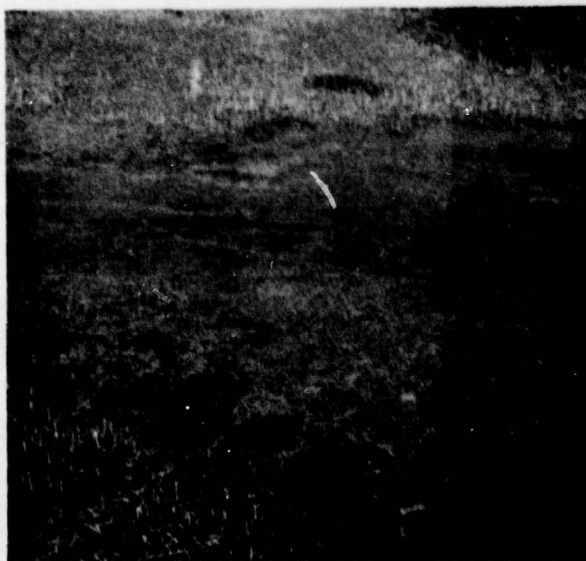
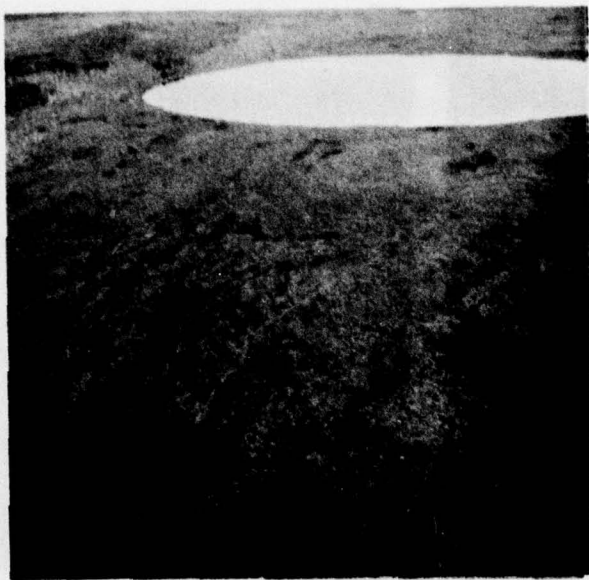
Troop concentration (Blair Lakes) (Figs. 44-57). The area contains an unpaved landing strip, a new trail (Fig. 50) and several old trails (such as shown in Fig. 51). Some vehicle tracks are visible on an old trail (Figs. 52 and 53), which are also detectable in the aerial view (at the intersection of the trails) in Figure 49.

Figure 44. Blair Lakes landing area (looking W).

Figure 45. Overall view of troop concentration and landing area (looking SE).

Figure 46. Western section of bivouac area (looking N).

Figure 47. Landing area (looking S).

Figure 48. Eastern section of
bivouac area (looking E).

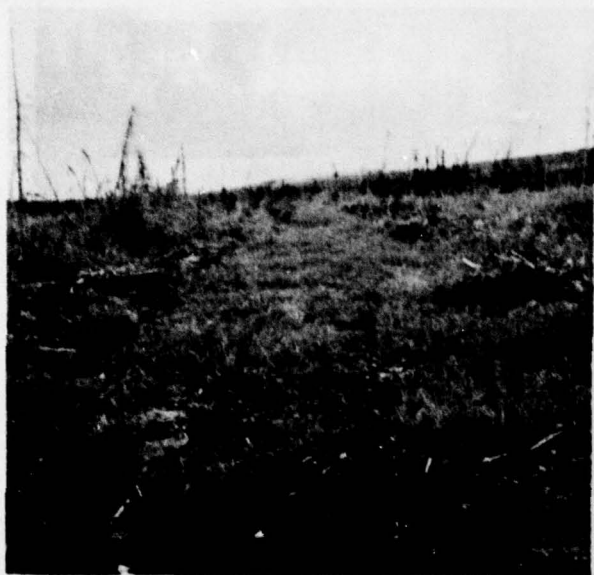
Figure 50. New trail
(looking SE).

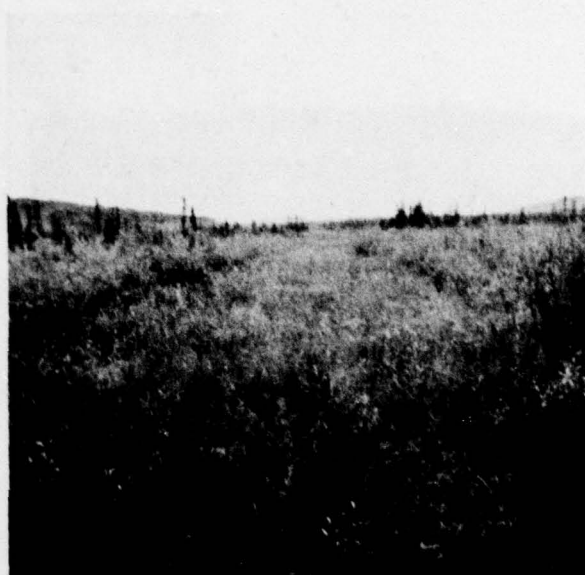
Figure 51. Old trail
(looking E).

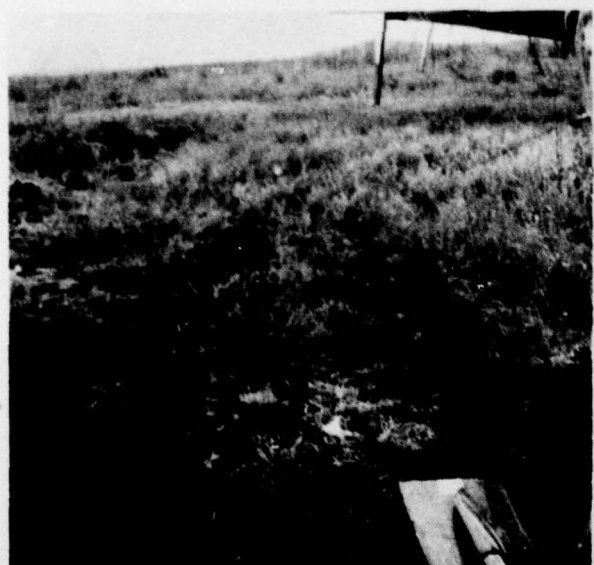
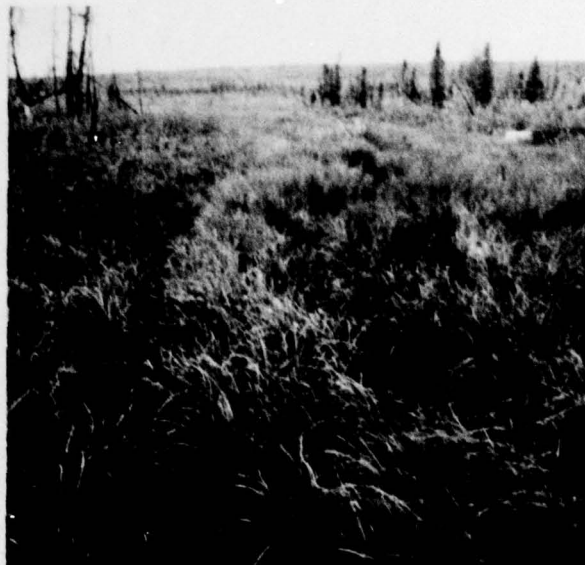
Figure 52. Vehicle tracks in old trail
(looking E).

Figure 53. Vehicle tracks in old trail
(looking S).

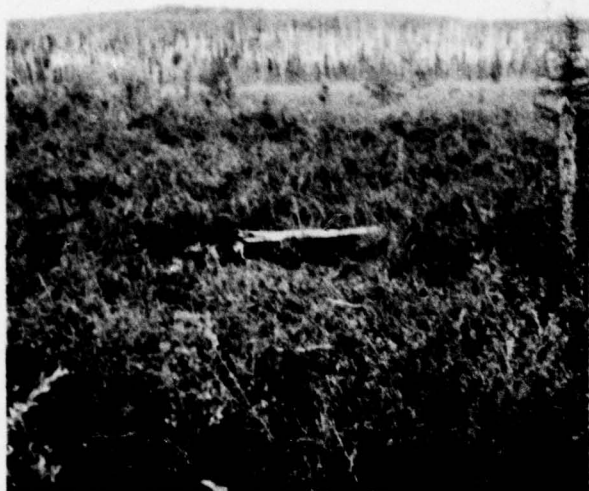
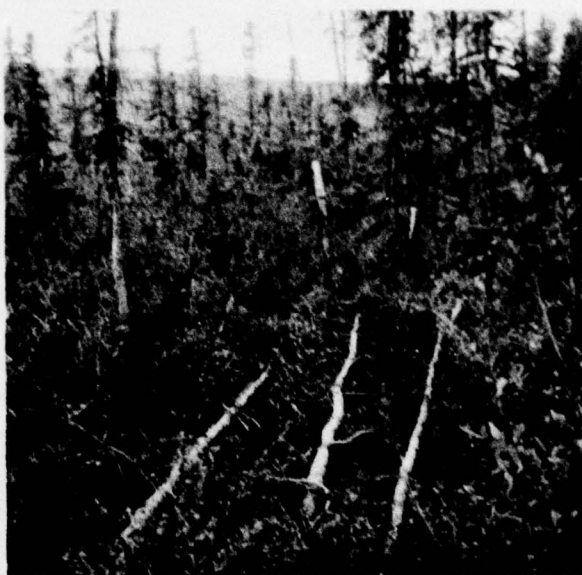
A couple of typical bivouac sites are shown in Figures 54 and 55. A dump site, with ashes still visible, is shown in Figure 56. The communications center site is shown in Figure 57. The cleanup in all of these areas has been rather thorough. Some minor debris, such as sections of communications wire, ration containers, and empty cigarette packs, were well hidden by the vegetation. From the air, the only visible signatures at this particular area were the trails. A number of fuel drums were observed at other sites in the Blair Lakes area.

Figure 54. Bivouac site,
north of trail.

Figure 55. Bivouac site,
south of trail

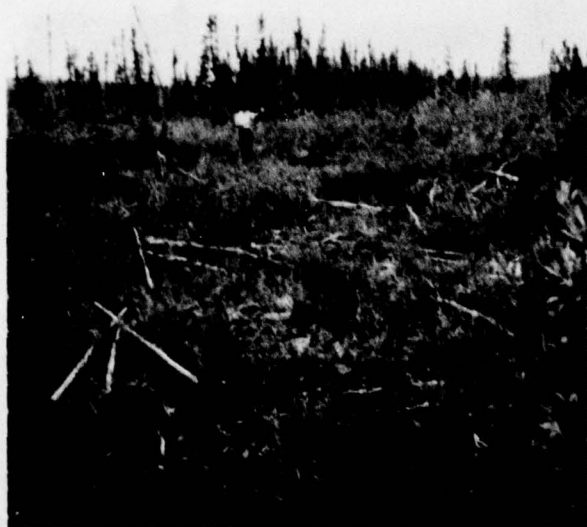
Figure 56. Dump site.

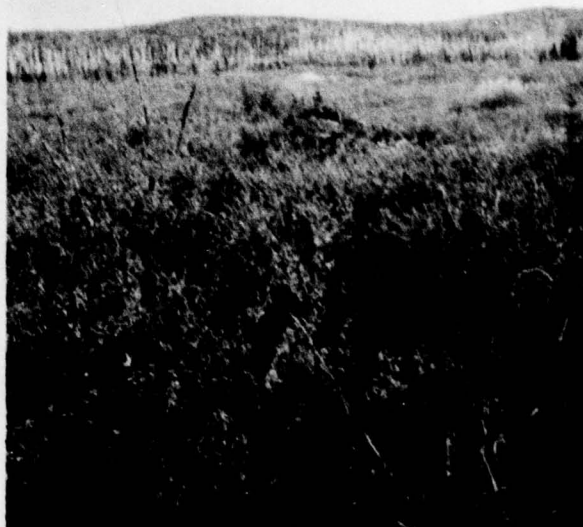
Figure 57. Communications
center site.

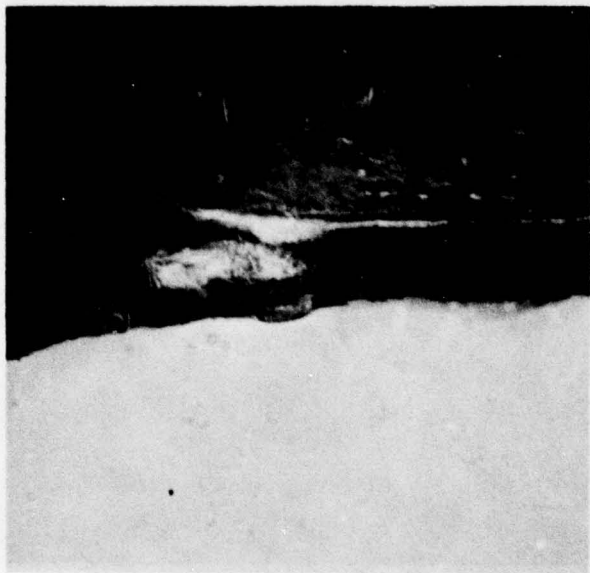
The location where an ice bridge was built from the east shore to the river, is shown in Figure 58. Removal of trees between the road and the river and some grading of the bank are the only obvious signs of disturbance. The river crossing, which was done over an area similar to that shown in Figure 59, left no visible marks.

Figure 58. Location of ice bridge,
east bank of Tanana River.

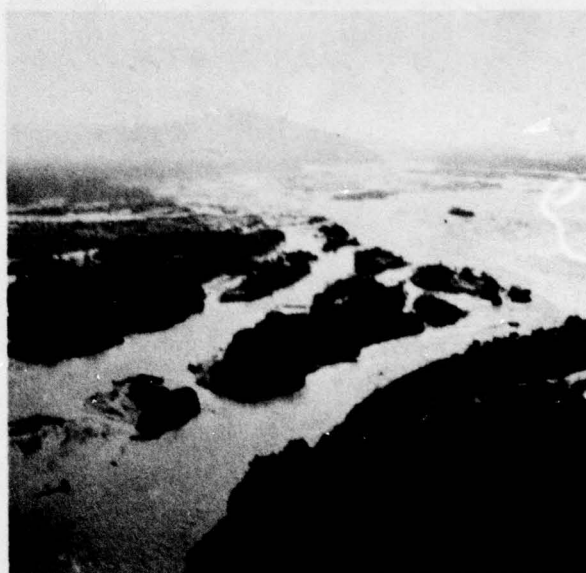
Figure 59. View of Tanana River
S of Eielson AFB (looking S)

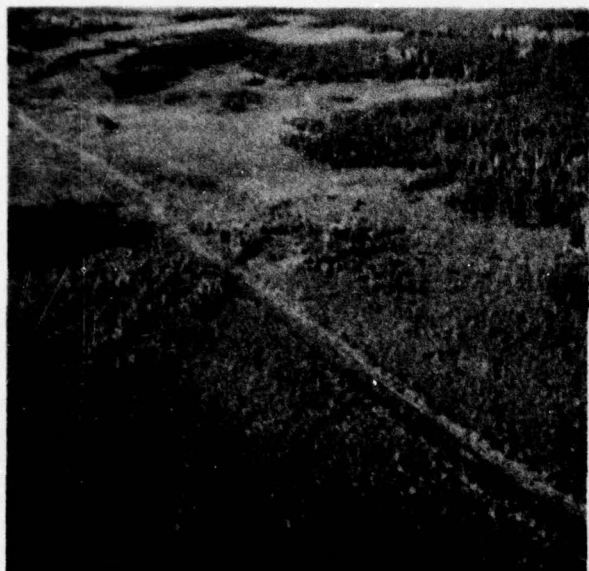
Figure 62. Tanana to Blair Lakes trail (looking N).

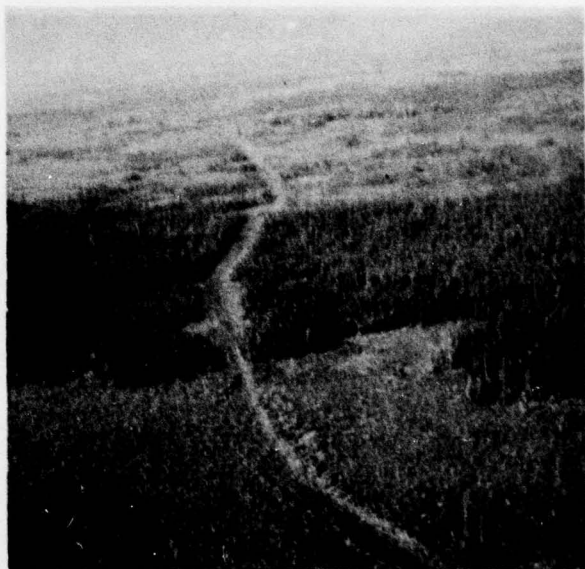
Figure 63. Tanana to Blair Lakes trail (looking N).

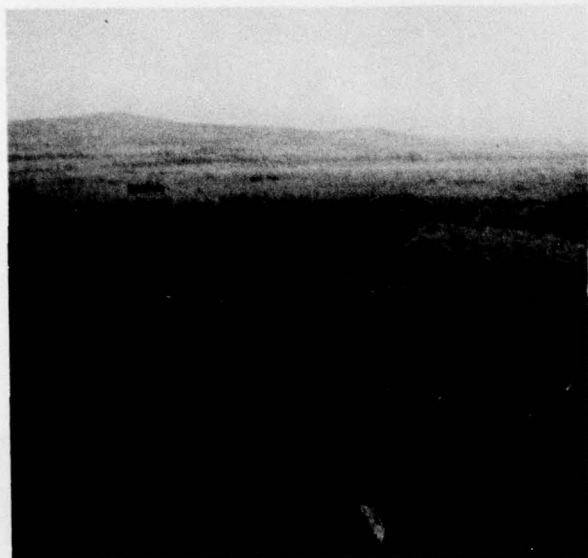
Figure 64. Trails east of Blair Lakes (looking N).

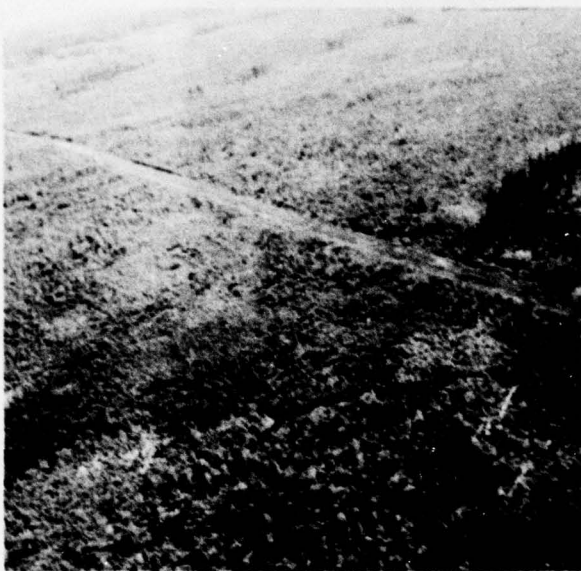
Figure 66. Tanana to Blair Lakes trail (looking SE).

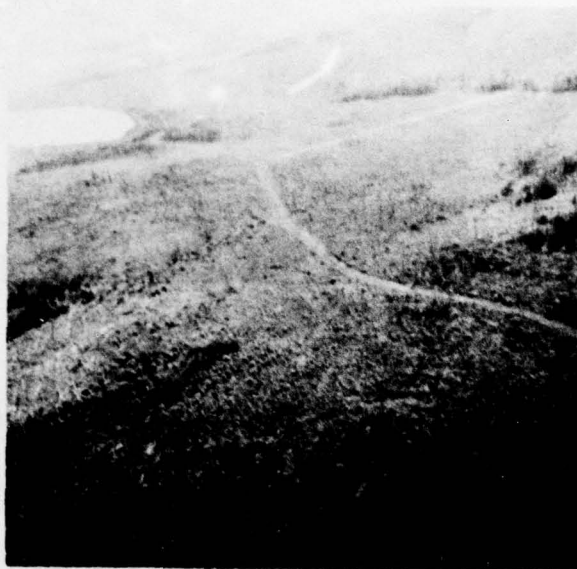
Figure 67. Tanana to Blair Lakes trail (looking SE).

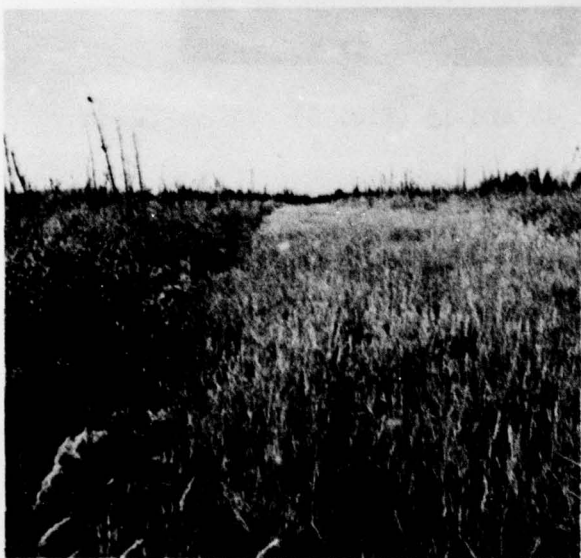
The beginning of the trail on the west bank of the river is shown in Figure 60, and the continuation of the trail toward west in Figures 61 through 67. In one poorly drained area (Fig. 65), vehicle trails were observed off the original trail which showed noticeable subsidence and had resulted in a depression below the water level. Ground inspection was made at one location on the trail to observe the vegetation regrowth (Figs. 68 and 69).

Figure 68. Ground view of trail (looking W).

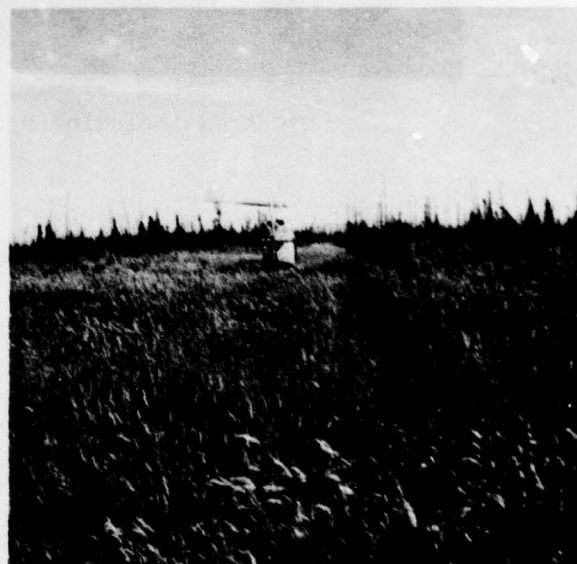
Figure 69. Ground view of trail (looking E).

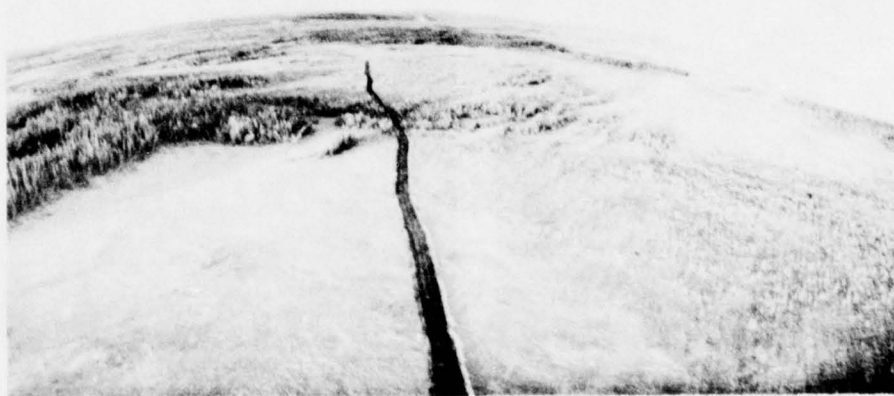
Figure 70 shows aerial views of 3 sections of the new trail SE of Clear Creek Butte shortly after the trail had been cut. Figure 70a shows the bog area where the bulldozer blade did not penetrate into the soil. This view contains the area shown in Figures 40 and 41. Figure 70b contains sites 14 and 15, where considerable vegetation and soil removal had occurred (refer to Fig. 5). Figure 70c includes sites 10 through 13 (refer to Figure 4).

c) Area including sites 10 through 13 (Fig. 4)
